A club member's story on the restoration project of his

1972 Jarama S

Part 2

Dissecting a frog

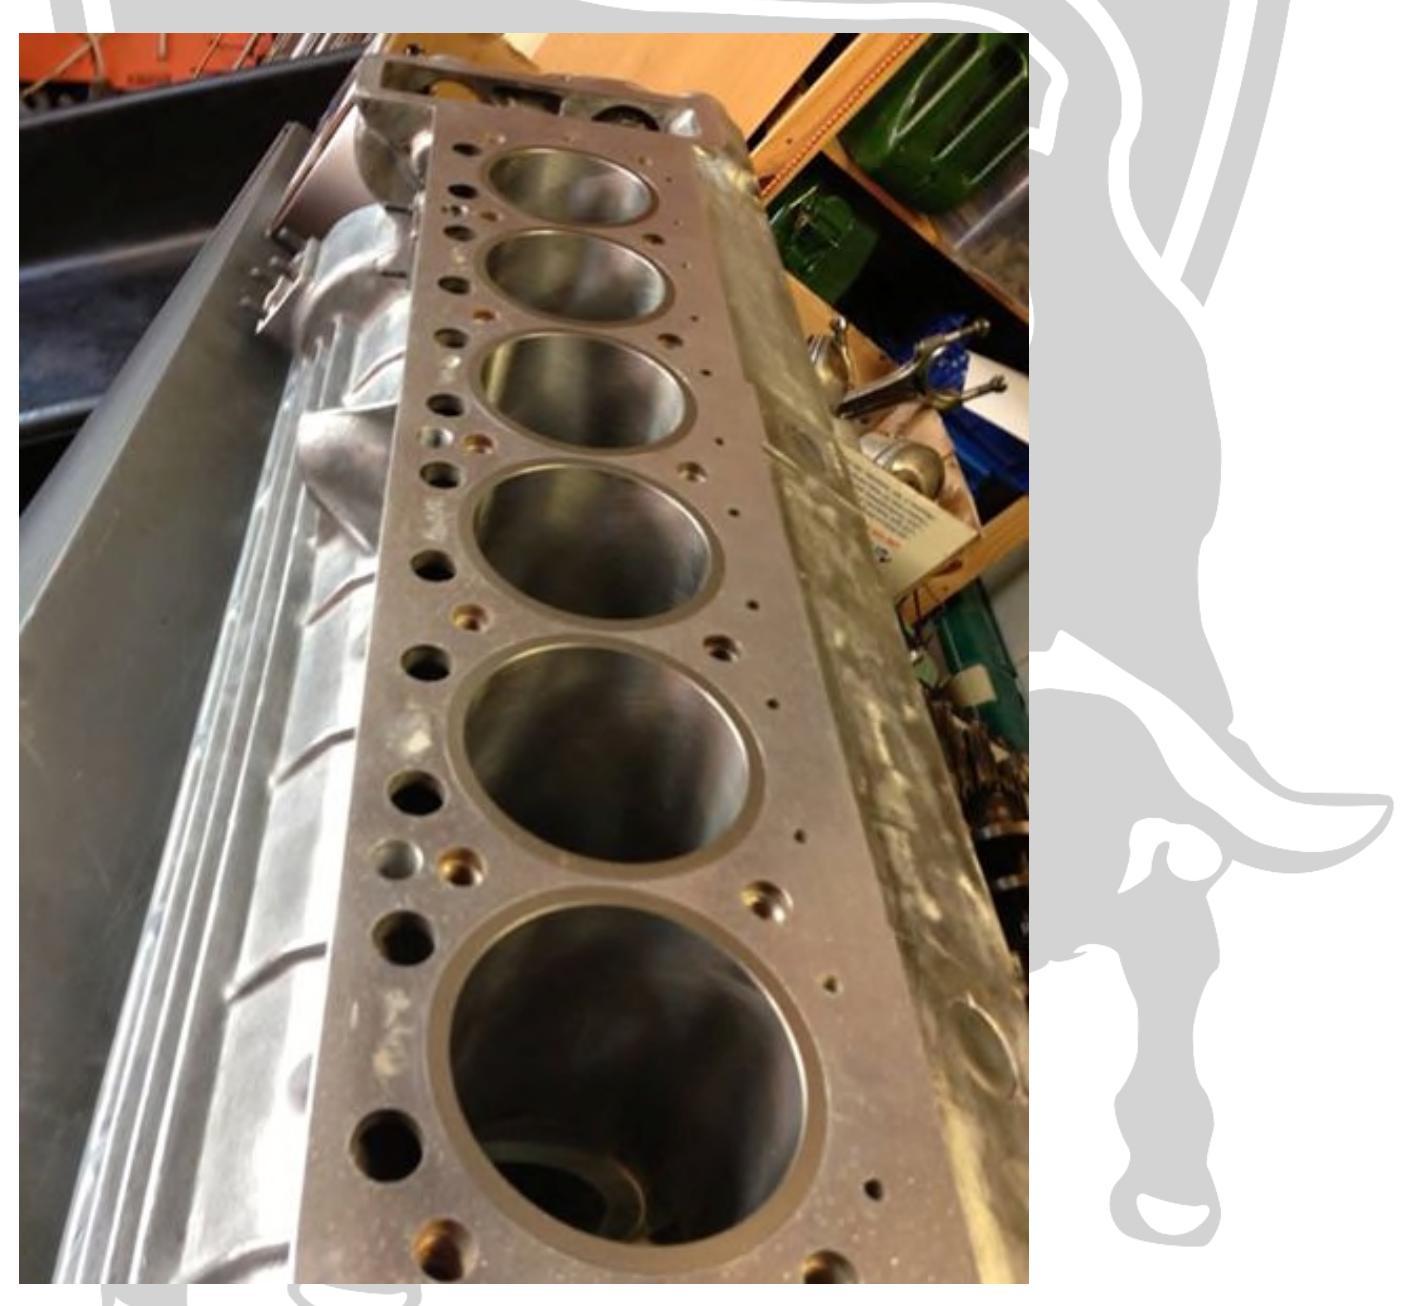
Here you can see slight corrosion between each pair of large coolant channels. This is very common on these engines and the reason is because the head is hollow on the mating surface added to the fact that aluminium does react with

water. Check your antifreeze guys, as this will prevent it. I'm going to fill Kermit up with waterless coolant when I'm finished to eliminate this problem altogether.

With the sand cast block skimmed you can see the imperfections in the casting. You can just about make out that the liners are not quite flush.

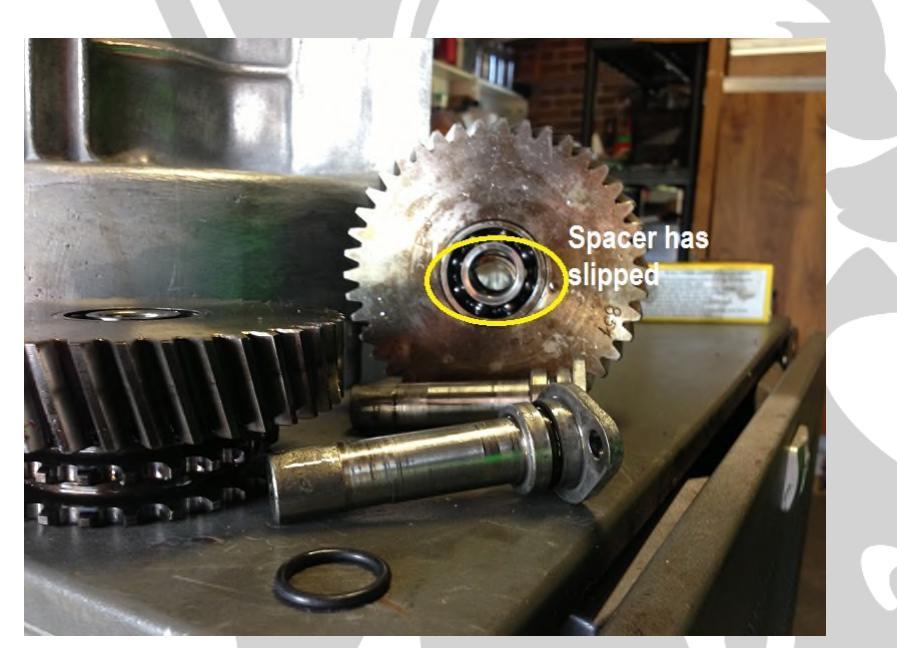
First Job

First job is to upend the crankcase so it sits on the flywheel end. Now install the M6 studs on the front and the timing chain drive gears. These gears must be done before the crankshaft goes in. The reason for doing this vertically is that a spacer is sandwiched between 2 ball bearing races in the timing chain gear and this spacer slips down between the 2 bearings preventing the pin from being inserted. When vertical it stays in place.

The end of the crankshaft drives these gears and then these gears drive the oil pump when it is fitted.

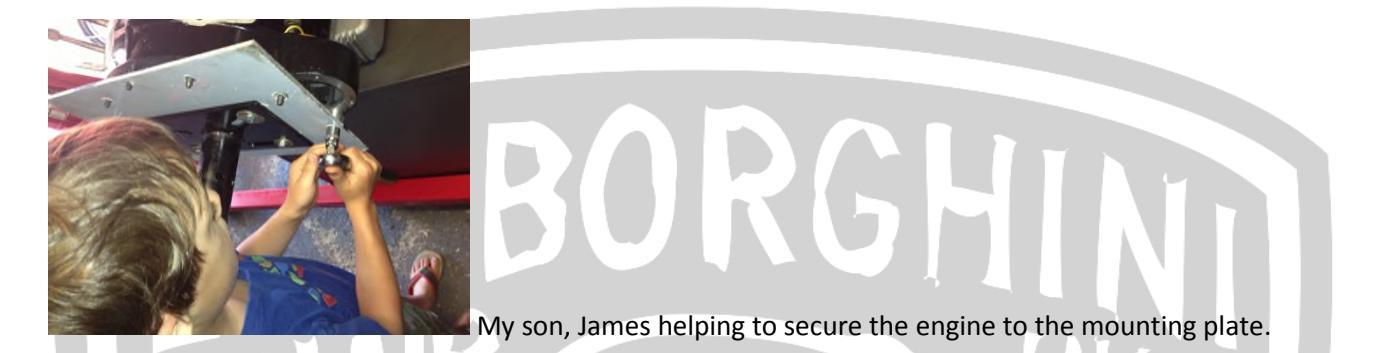
Now that's done it's time to get the block on the engine stand. I've made a plate from aluminium that bolts to the flywheel end. This will attach to the M8 studs that are installed in this end.

Next job is to install the rest of the studs. There are M6 sump studs, 2 M8 head studs, the 28 head bolts and the main bearing cap studs of which there are 14 large inner studs and 14 small outer studs.

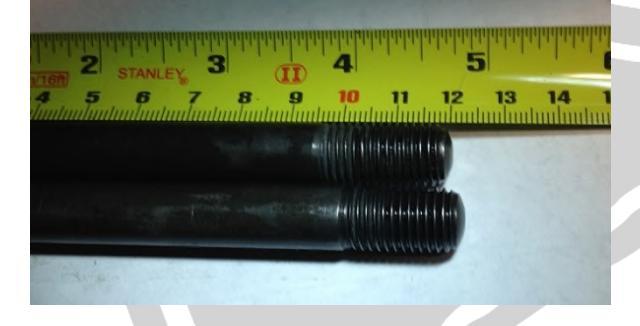
The large main bearing studs look all the same but they are not. They are 120mm in length except 2 which are 123mm. You can almost miss this difference (which I did initially) but it is important that the two longer studs are installed for cap #7. This cap is taller and thicker than the others as this is because it houses the shims that control the crank float.

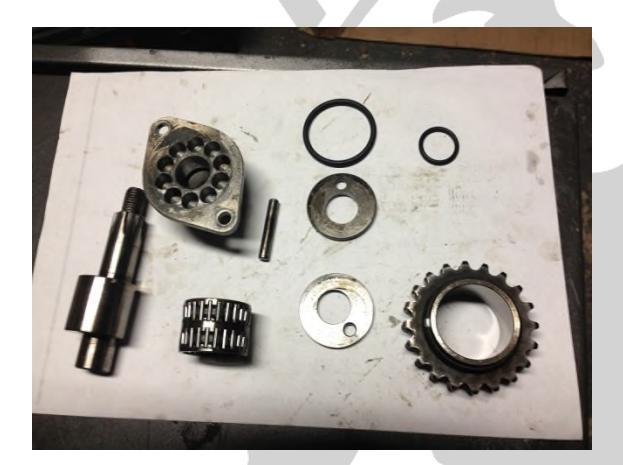
Timing chain adjusters are installed. These devices adjust the tension of the timing chains. All oil o-ring seals are being replaced. The old oil seals were solid and broke apart. I probably should be thankful for the poor oil seals as the coating of oil in the engine bay and underneath the car has preserved the bodywork quite well.

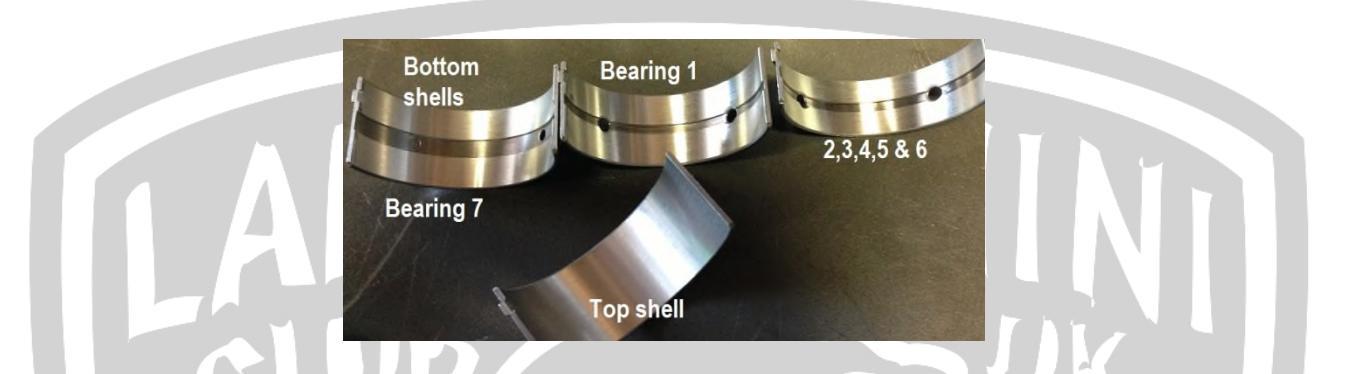
Nice new shiny big end shells are all installed and diameters checked with the appropriate journal on the crank.

Main shells come in three differing sizes. The largest is for bearing #7 the next largest is for bearing #1 and the rest go in the others. The oil feed comes from the top of the crankcase through a groove to the bearing cap and out of two holes in the lower shell. So it goes that the solid shell is installed in the crankcase and the grooved shell is in the cap. I've done this and torqued them down (sans crank). Inside diameter on all are 63.007 and this is compared with the corresponding journal on the crank. Journals 1 to 7 are 63.002, 63.001,62.997,62.998,62.997,62.997 and 62.997. All within tolerance. Caps are then removed awaiting the installation of the crankshaft.

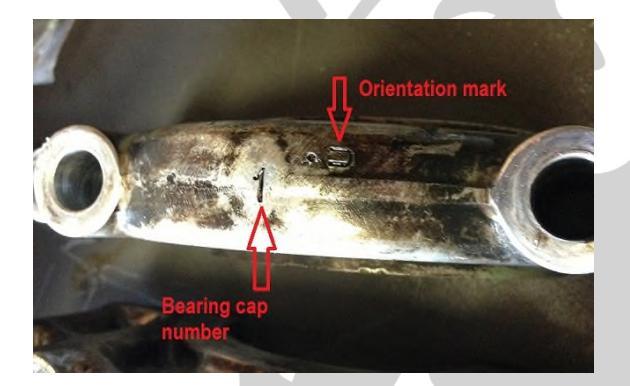
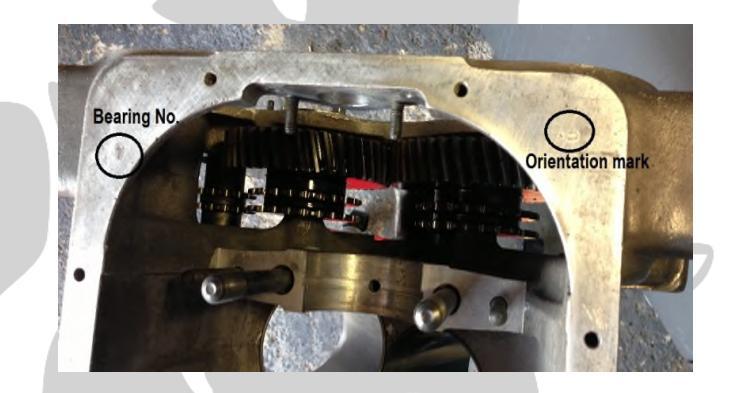
Main bearing caps are stamped with the numbers 1 to 7. 1 is at the timing gear end and 7 next to the flywheel. There is also another mark on each cap to one side and I think this is an orientation mark to make sure the cap is installed the right way round. This orientation mark may have been put on by another mechanic as this is not a Lamborghini mark (officially anyway).

Having stated that, my friend Marc in the U.S. also has a Jarama and his engine has the very same orientation marks on the case and caps so it would be interesting to see more engines of this type.

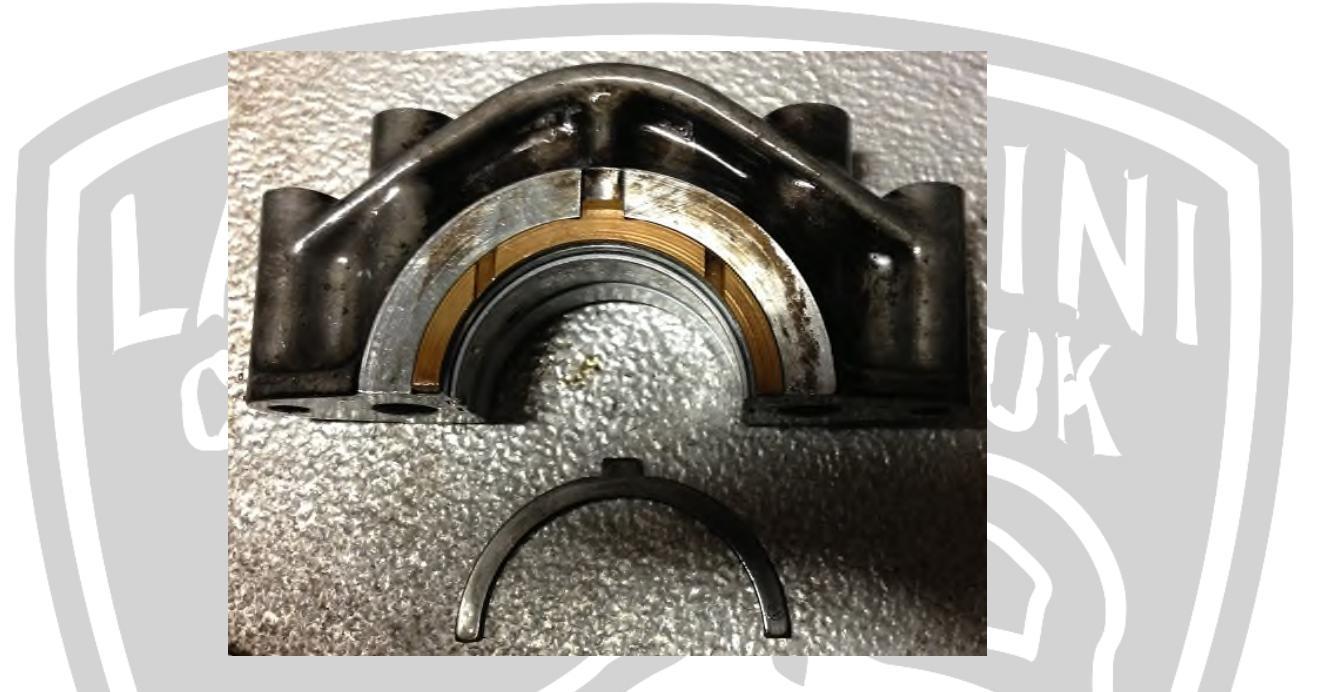
Crankshaft

In goes the crankshaft. This thing is a work of art and was machined out of a solid bar of Nickel-Chrome-Molybdenum steel and took nearly a week to make. When the engine is first started there will be no oil pressure for several seconds as the oil pump sucks up oil from the sump, fills up the oil filter and pumps oil through all the little channels in the engine. Because of this every component is getting a liberal covering of nice thick green 20W50 engine oil.

Torque the caps 1,2,4,5 and 6. Tighten cap 3 but don't bother torqueing it down until later as the oil pickup goes under those nuts once all the pistons are in place. The float shims (without the tabs) are fed in the slots between the crankshaft and the crankcase at bearing 7 (flywheel end) making sure the slotted surfaces are facing away from each other.

The crankfloat is then measured (should be between 0.15 and 0.17mm) and then install the cap. The shims on the cap have a tab which hold them in place. These tabbed shims must have the slotted surface on the outside which means it is the surface next to the crankshaft.

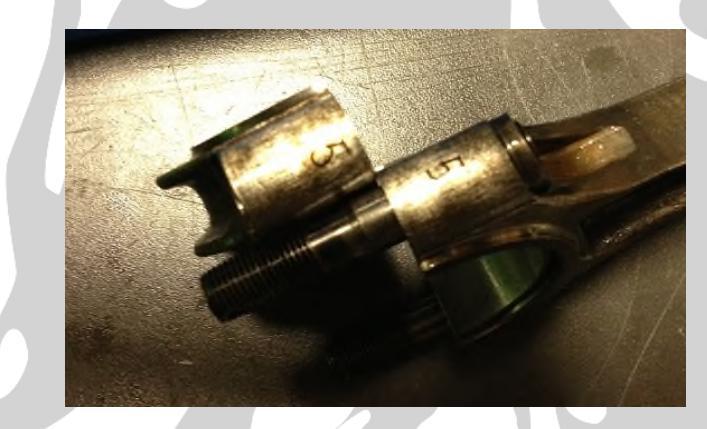
Piston ring gap has been checked at the top of the new bore and the bottom and it is between 11 and 14 thou. I'm happy with this so they can now be put on the pistons.

The connecting rods and ends are all marked with their weight and numbered (here we see number 5) so cap and rod can always be kept together. This is vital as the engine must be balanced or it will shake itself to destruction. It is also very important to make sure the piston is inserted into the block with the large inlet recess toward the top of the block. The pistons are inserted from the top so it is good to be gentle here as I don't want the con-rods scratching the newly fitted and honed liners. I also make sure all shells are generously covered in engine oil.

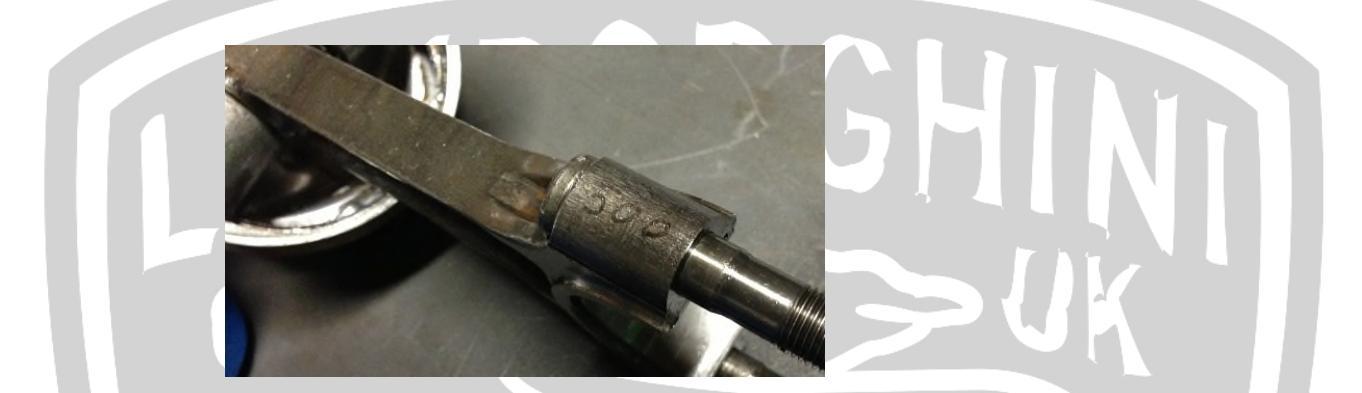
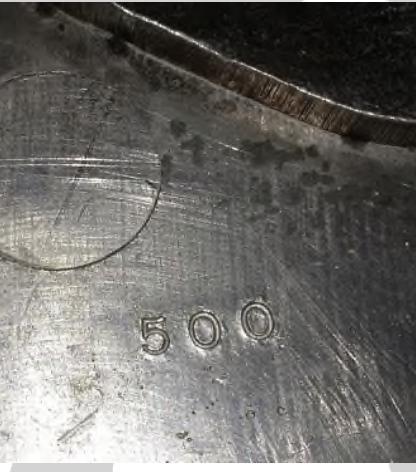
The weight is etched on my con rods (500 grams). For some reason Lamborghini felt it necessary to also stamp this weight on the crankcase. Why?

I'm certain these markings are by Lamborghini as once again Marc's Jarama has similar markings. His con-rod weight is 486 and 486 is also stamped on the front of the crankcase.

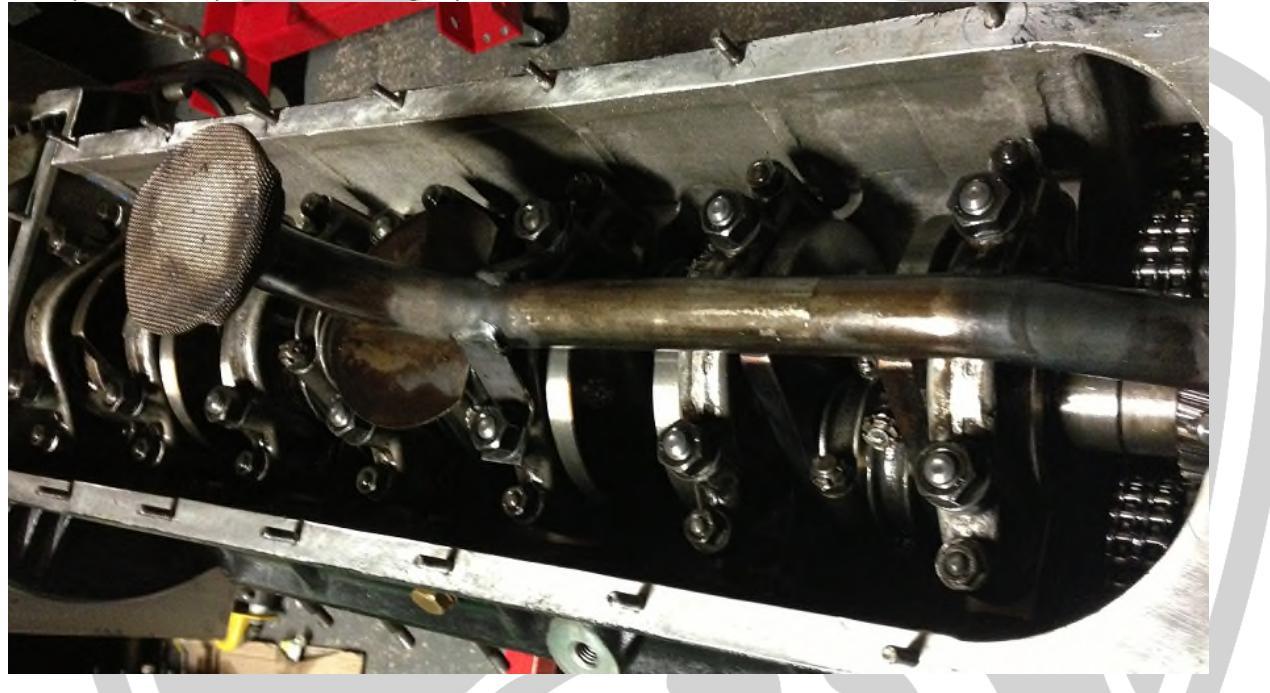
I now turn the crankshaft to roughly Top Dead Centre (TDC) i.e. piston number 1 at the top of travel. Drop the timing chains in so you have roughly equal lengths hanging down for all 4 ends and then put in the oil suction pipe.

Now you can torque down bearing cap number 3.

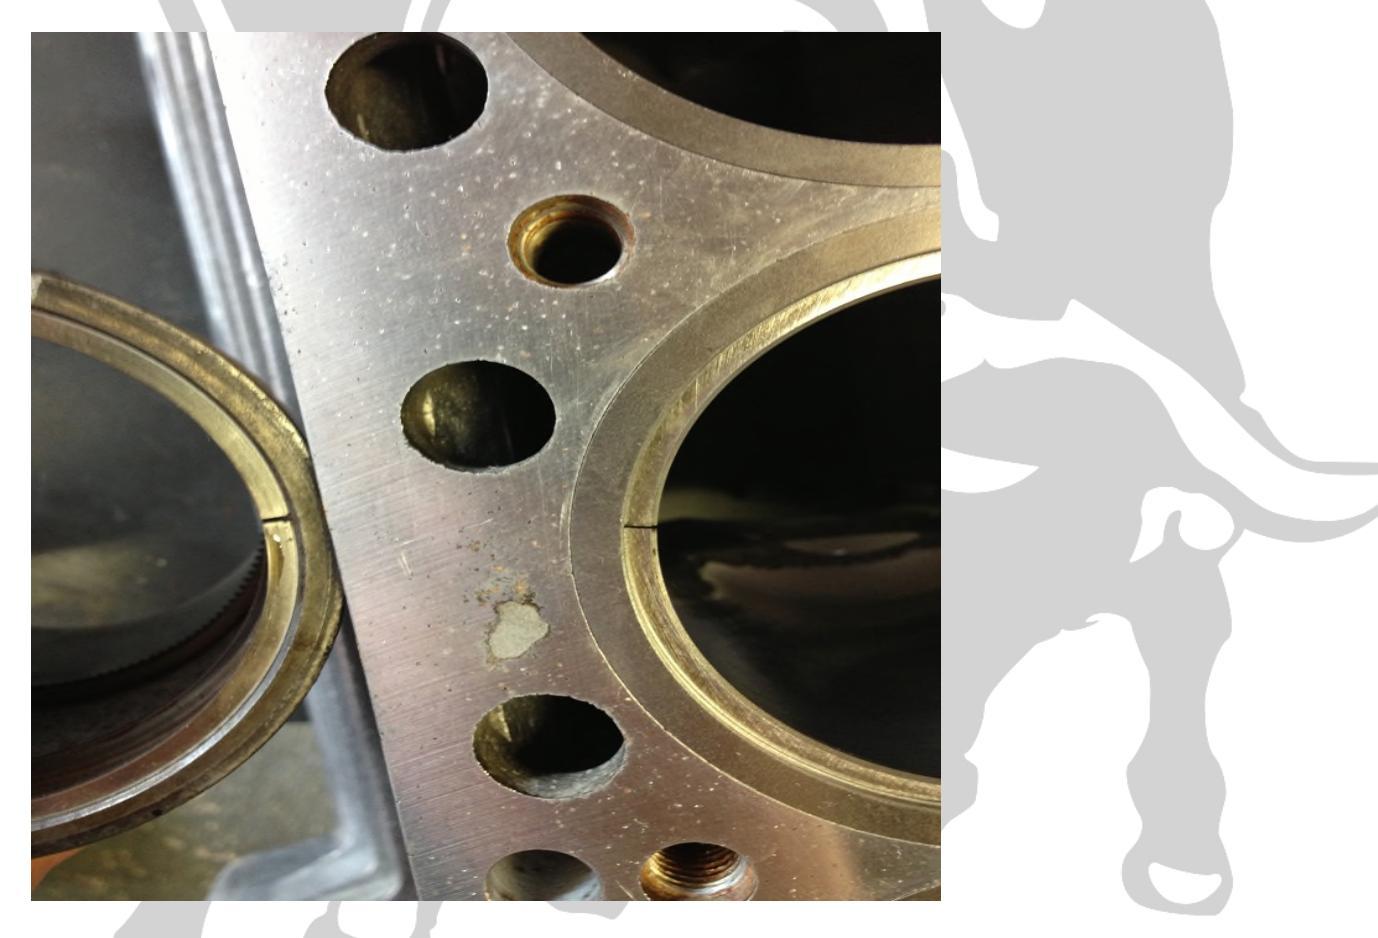
Here you can see the new ring gap versus the old. New gap is 11 thou, old is 47!
